# SVFUDS PSB HILLSIDE REMEDIATION STATUS AUGUST 2023

Weston Solutions, Inc.  
August 8, 2023

# PSB HILLSIDE PROPOSED EXCAVATION EXTENT

# PSB HILLSIDE RETAINING WALL DETAILS

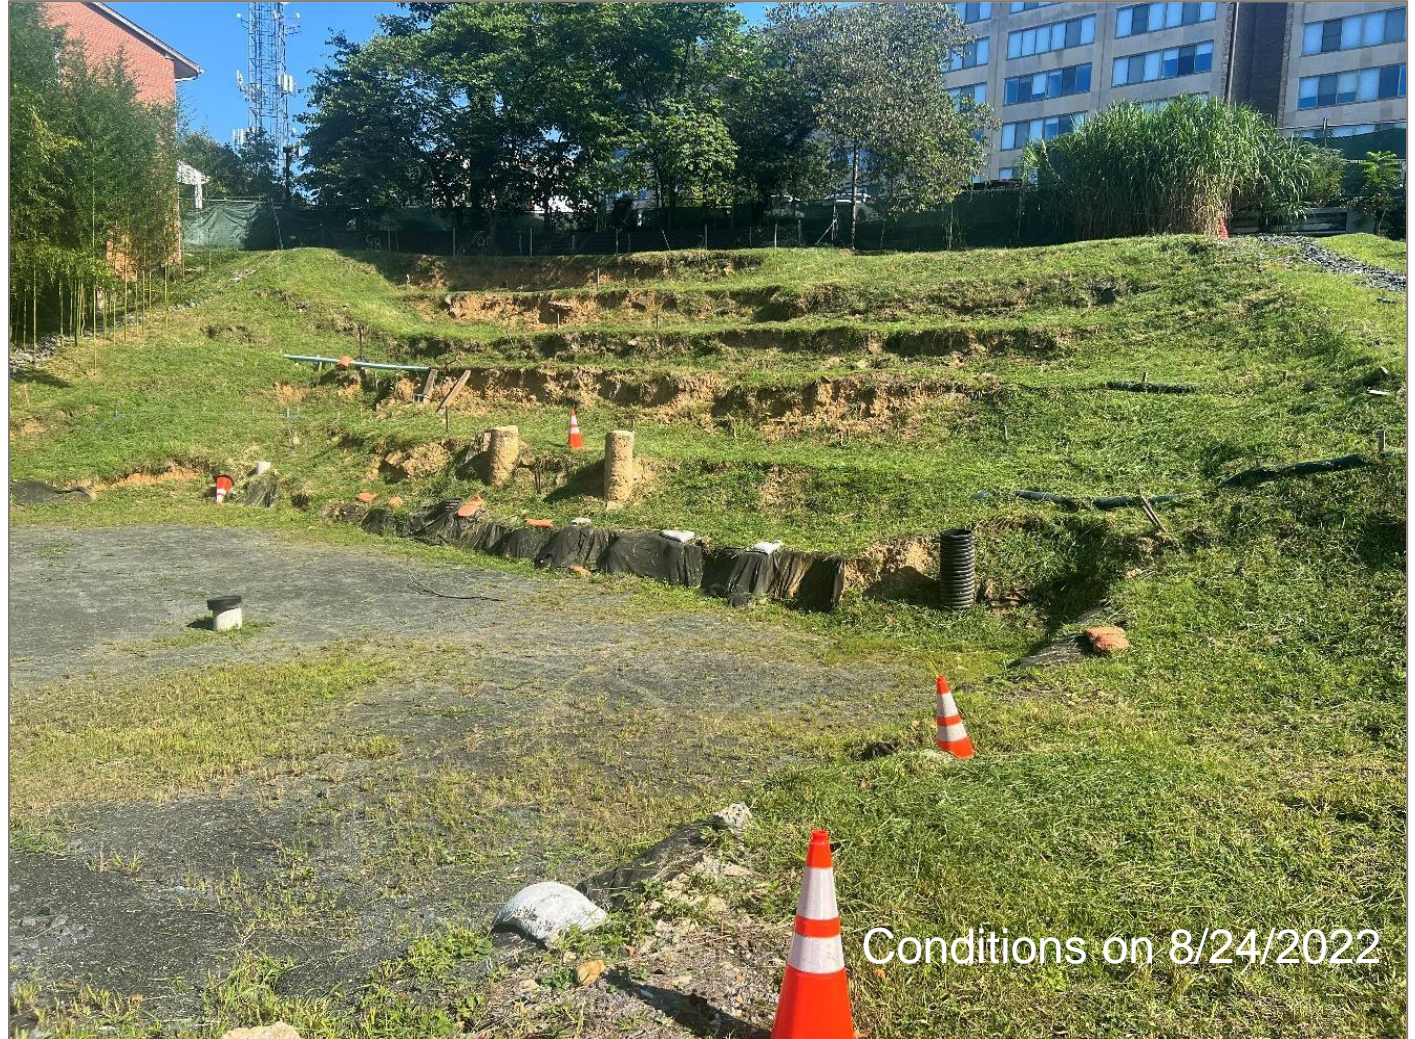
- Weston demobilized from the PSB on 16 April 2021.
- PSB Confirmation Sample results met all SVFUDS cleanup criteria.
- Completed E&S Control Inspections every other week April – present.
- PSB slope and soil benches are vegetated and stable.
- Mowing & Fence repairs ongoing.

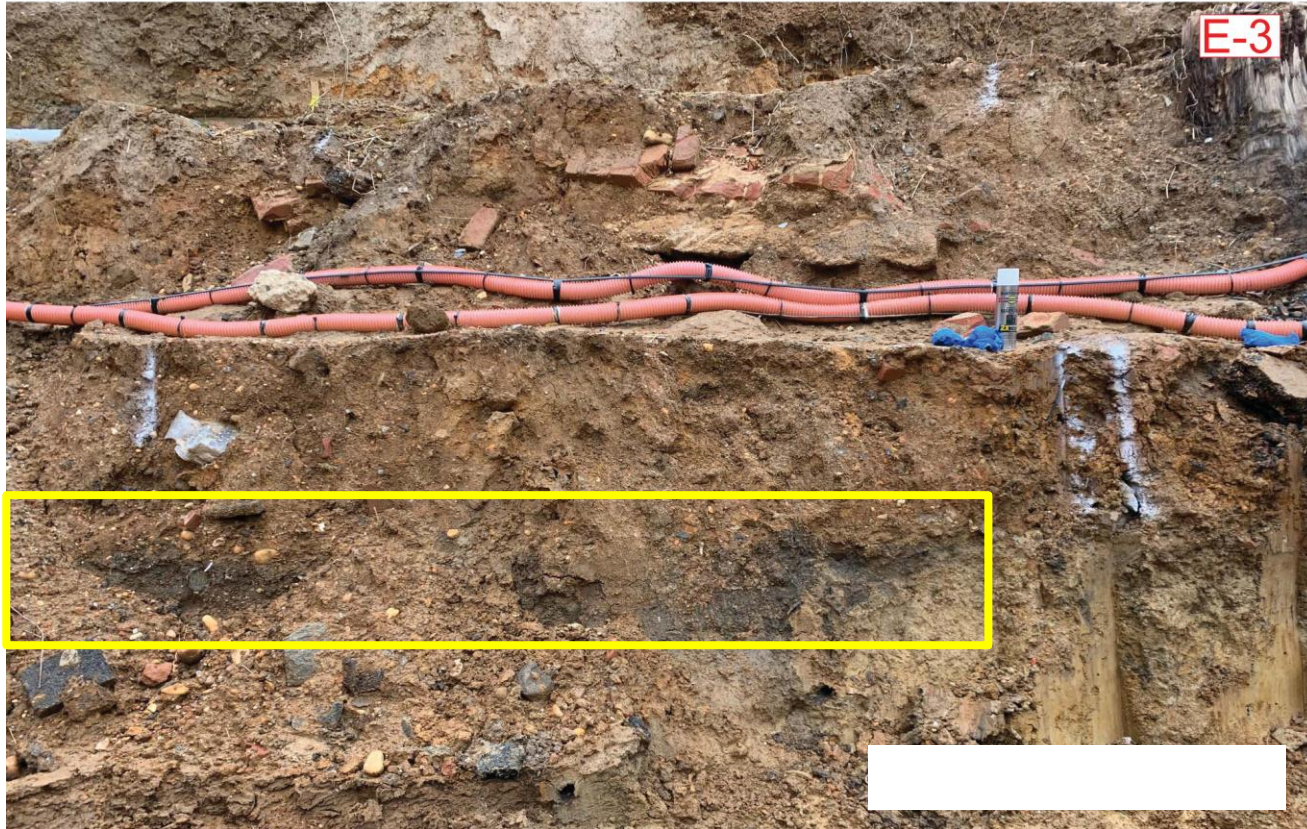
Photo of North Wall of PSB Foundation Excavation with yellow box showing Black AUES Debris layer about 1 foot below the former PSB basement slab elevation. During the PSB Foundation excavation, AUES Debris was observed extending beyond the excavation wall.

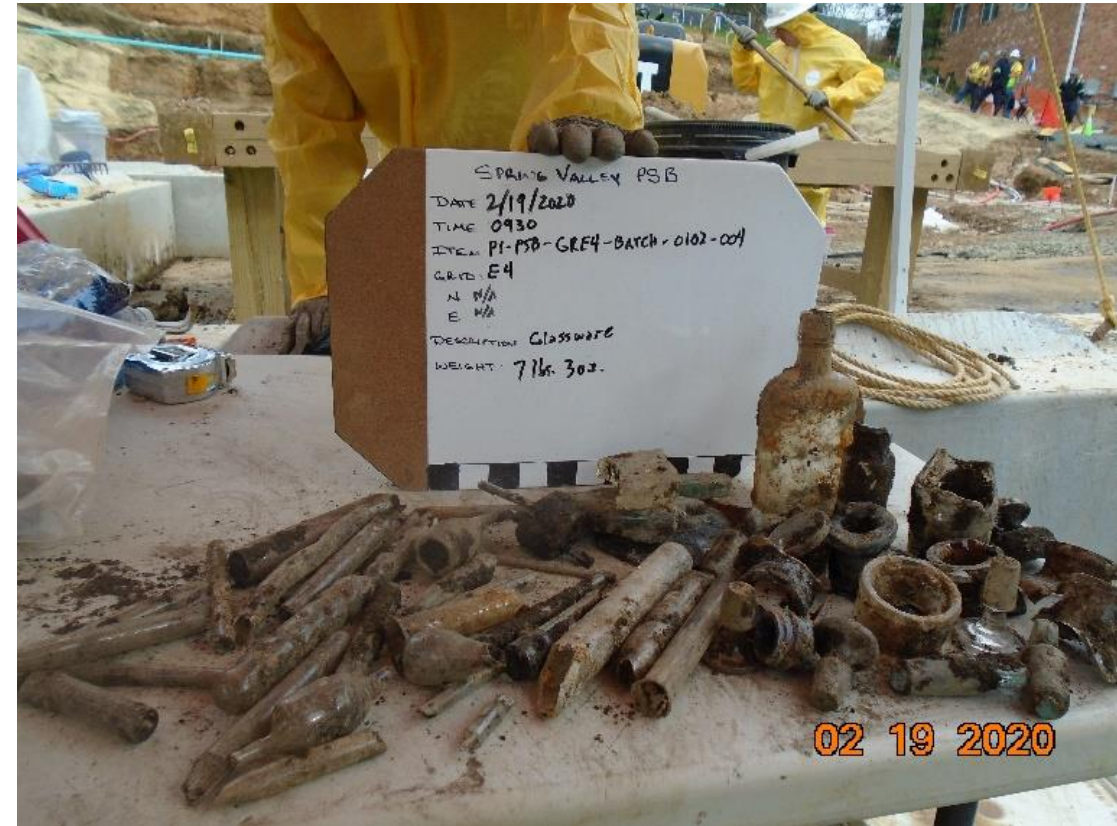
Examples of AUES Debris recovered: broken glass, glass jars, test tubes, ceramics, and metal pieces. No CWA was detected. One area had elevated metals in the soil and one test tube was found with possible TNT - both were removed.

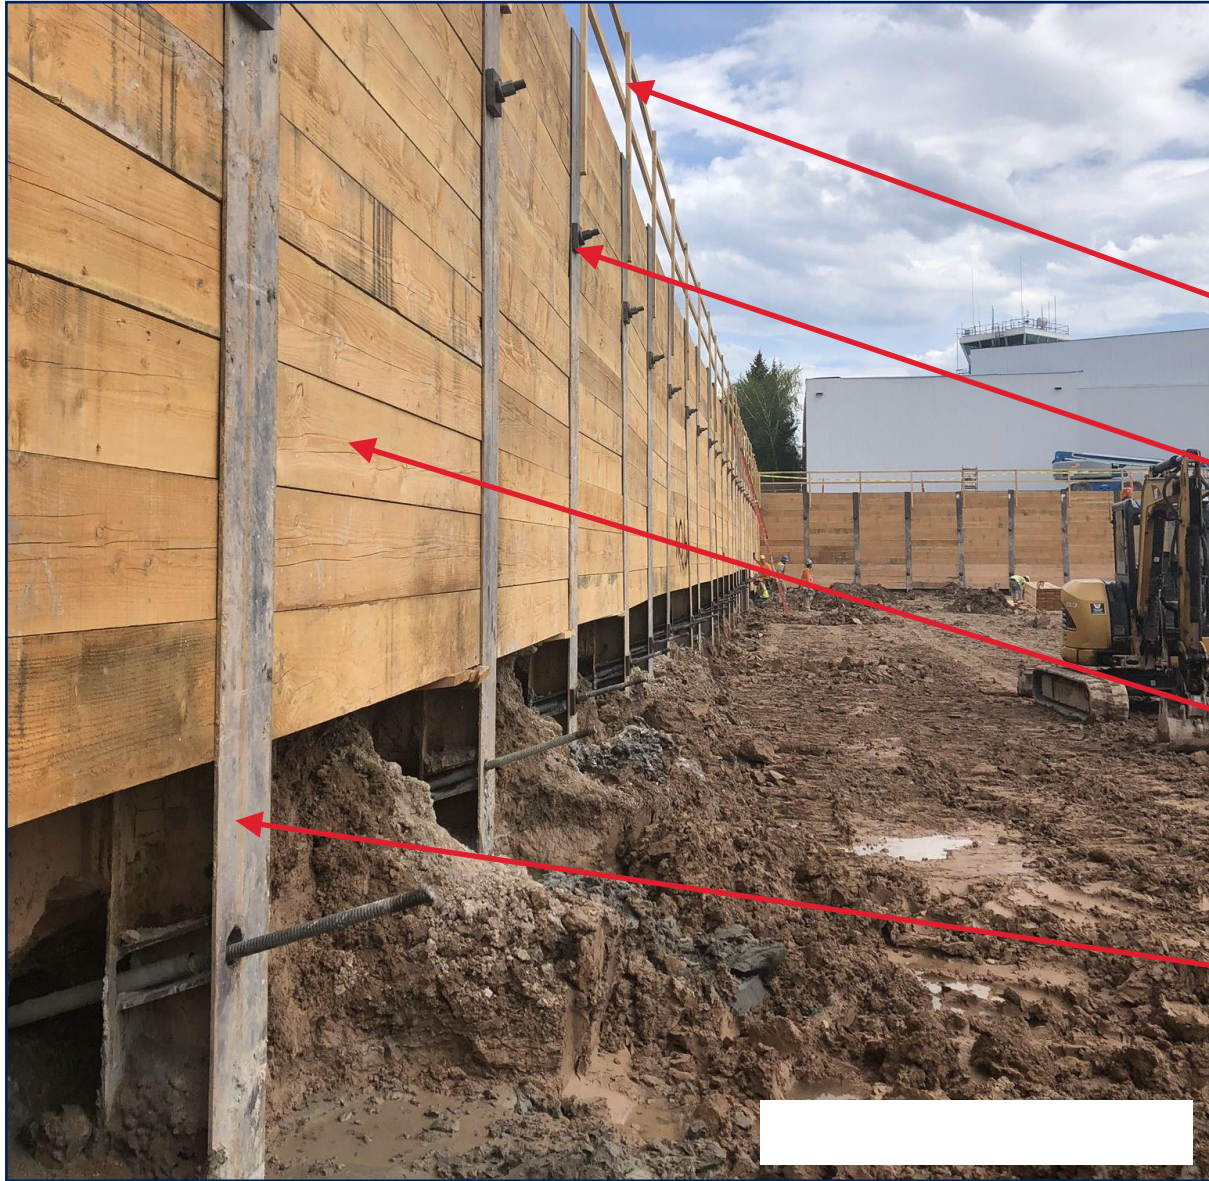
**Install ~14 ft Retaining Wall from elevation 362 ft down to 348 ft and excavate approx. 560 CY of Debris**

- **Safety Fence** – OSHA required safety fence at top of retaining wall.
- **Tiebacks** – set in angled borings and cemented in place to anchor the wall into the slope.
- **Wood Lagging** – installed by hand behind the front lip of the “H” piles to hold back the soil.
- **“H” Piles** – set in drilled holes and cemented in place. Designed to hold wood lagging boards.

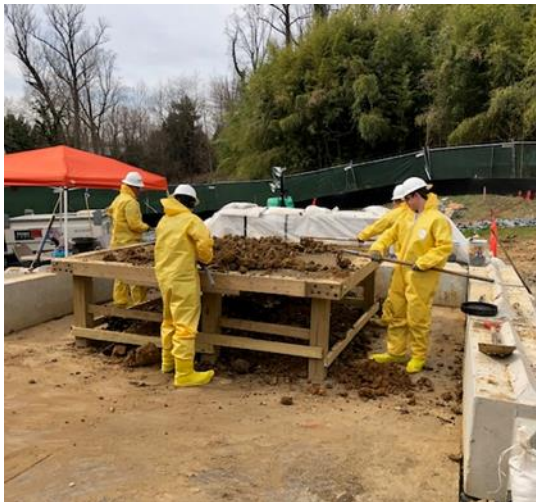
Sorting AUES Debris

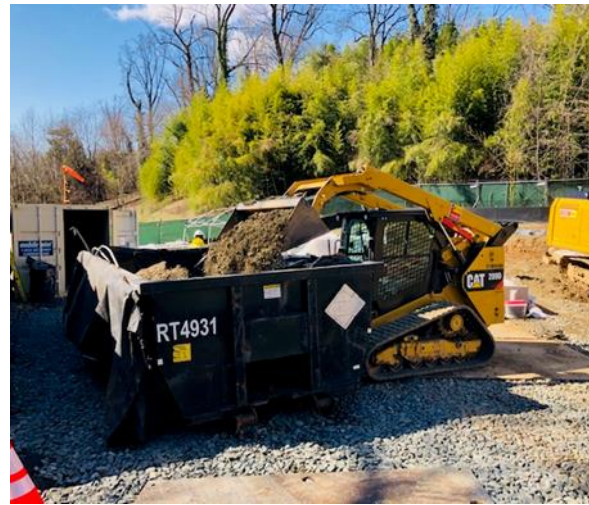
Loading Soil in Roll-Off
